CRASH SAFETY OF A TYPICAL BAY TABLE IN A RAILWAY VEHICLE

Summary. Increasingly, urban and high speed trains are incorporating tables (workstations) as common railway vehicle interior furniture because passengers prefer seating by bay tables. Among table design characteristics, the most challenging is meeting crashworthiness requirements. Past accident data and sled test results have shown that in the event of railway vehicle frontal impact, occupants located in the bay seating are exposed to chest and abdominal injuries upon contact with tables resulting from secondary collision. In some cases tables have tended to be structurally weak; they easily detach from the side walls and/or floor mounting. Subsequently these become unguided missiles that strike occupants, resulting in injuries.

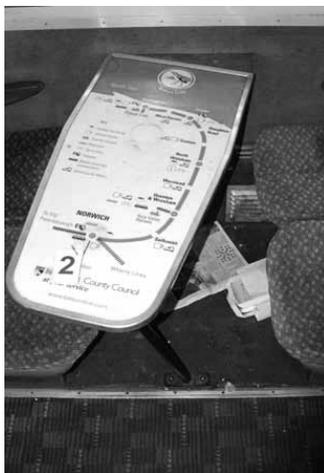
Although the train involved in the accident was not designed to withstand a collision with a large goods vehicle, the majority of the injuries were caused by the interaction of passengers and tables rather than by structural deformation of the vehicles themselves. The design of the tables may have contributed to the severity of the consequences of this accident.

Tables were either deformed (Fig. 1) or detached (Fig. 2).

Fig. 1. Typical example of table deformation
Rys. 1. Typowy przykład odkształcenia stołu

Due to the injuries caused by tables, one of the recommendations made in the report was: “a review of the crashworthiness performance of the tables in the type of train involved in the accident”.

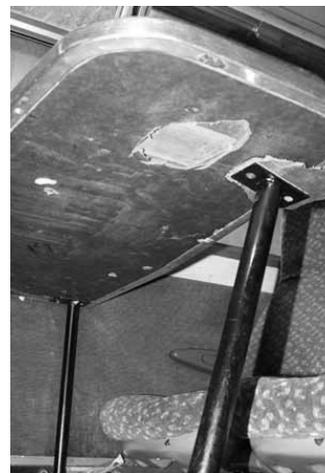
Fig. 2. Typical example of table detachment
Rys. 2. Typowy przykład oderwania stołu

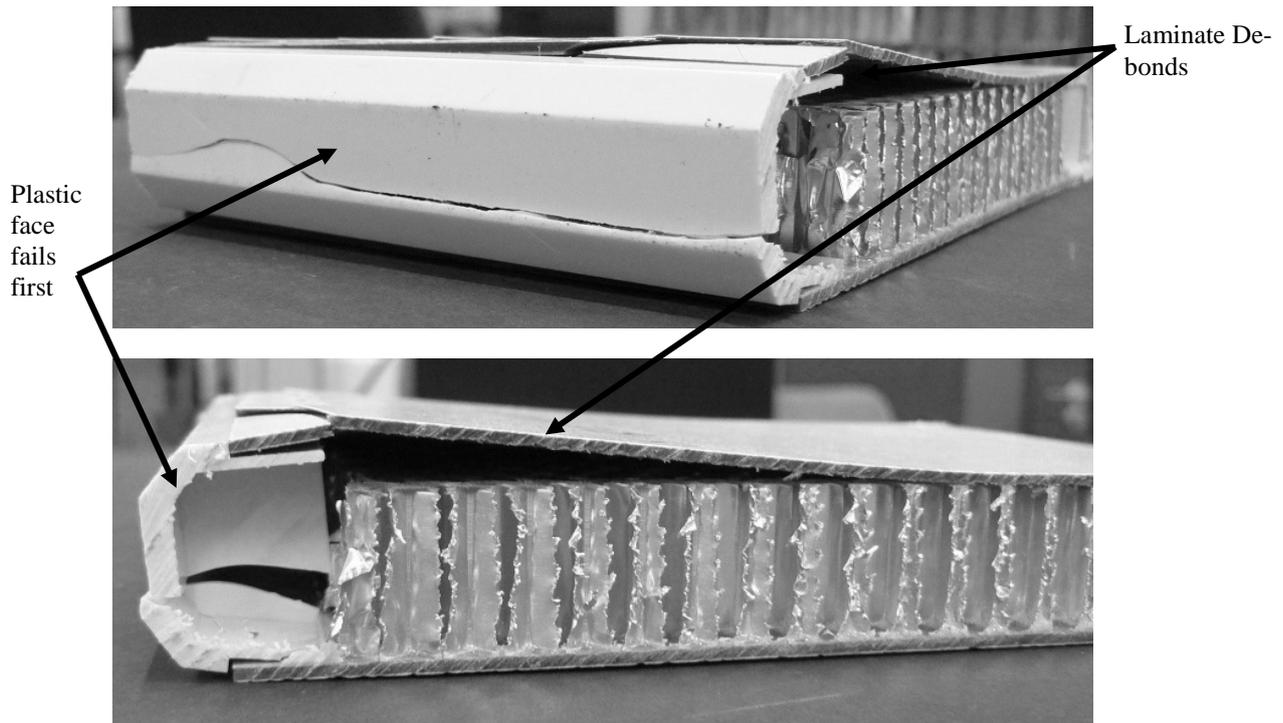
Upon loading the test specimen, the front plastic collapses, then its edges push the laminates sideward (see Fig. 8). Subsequently, de-bonding between the laminate and honeycomb core occurs, resulting in the final abrupt collapse. The composite had a yield and ultimate compressive strengths of 6.0MPa/7.2MPa, respectively. It was observed that during the test, the flap did not fold about the table hinge.

From the tests conducted, it was concluded that failure of the full composite is triggered by the collapse of the front (occupant impact part) plastic through the failure mechanism described earlier, with the Young's Modulus ranging from 1GPa to 1.2GPa. The ultimate strength of the flap under quasi-static loading is 7.2MPa.

The maximum load for this test with a width of 100mm and thickness of 22mm was 15.8kN. As such, the maximum load for a width of 300mm (equivalent to a body block impact width) would be 47.6kN, - a loading far higher than the 0.5kN to 6kN range for injury tolerance of abdominal organs [8,9] and 8kN tolerance of the chest [9]. This implies that the occupant is far weaker than table edge. In the event of an impact, it is expected that the occupant could suffer fatal injuries.

Fig. 8. Failure (mechanism) of the Complete Composite structure
 Fig. 8. Uszkodzenie (mechanizm) kompletnej struktury kompozytu

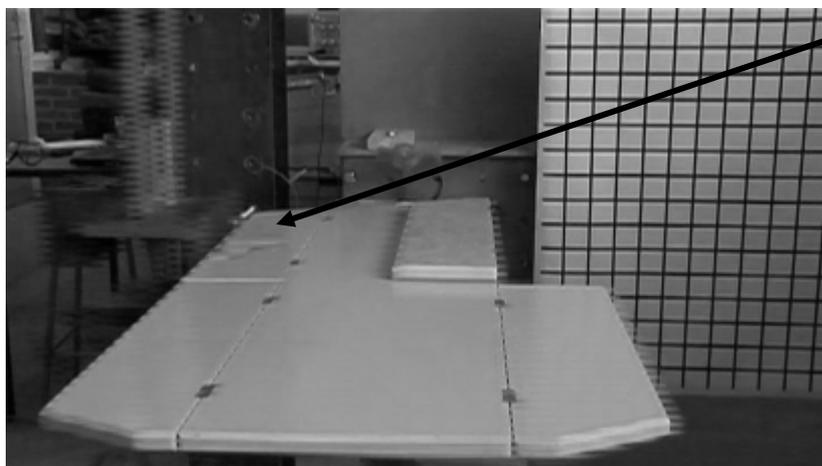
For the First Class table design, the impulse lasted for 10 ms, and the corresponding velocity change was 3.56 m/s. Fig. 9 shows the load curve as a function of time. Fig. 10 shows the frame from the video footage just after the pendulum struck the table. Soon after, the Formica top moved upwards (de-bonding). This failure mechanism is similar to the one observed during quasi-static tests of the table parts (see Section 3.1.1).

Laminate debonds and cracks appear at the surface

Fig. 10. Image Captured from First Class Test Video

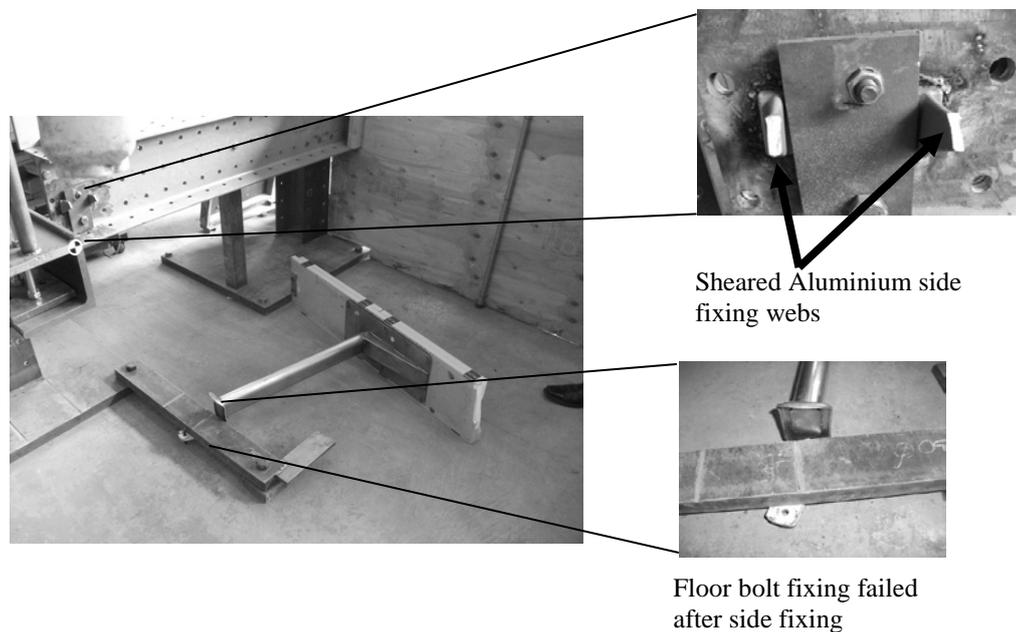
For this first Standard Class table design, the impulse lasted for 3ms, and the corresponding velocity change was 1.32 m/s. Fig. 11 shows the load and energy curves as a function of time. Upon impact, the aluminium side fixing webs sheared off, resulting in the table falling while hinged about the floor fixing. Subsequently, both the floor plate and the bolt on the side of impact collapsed under tension. Hence the table fell as shown in Fig. 12. The impacted flap remained intact.

Fig. 12. Still pictures after impact
Rys. 12. Obrazy po uderzeniu

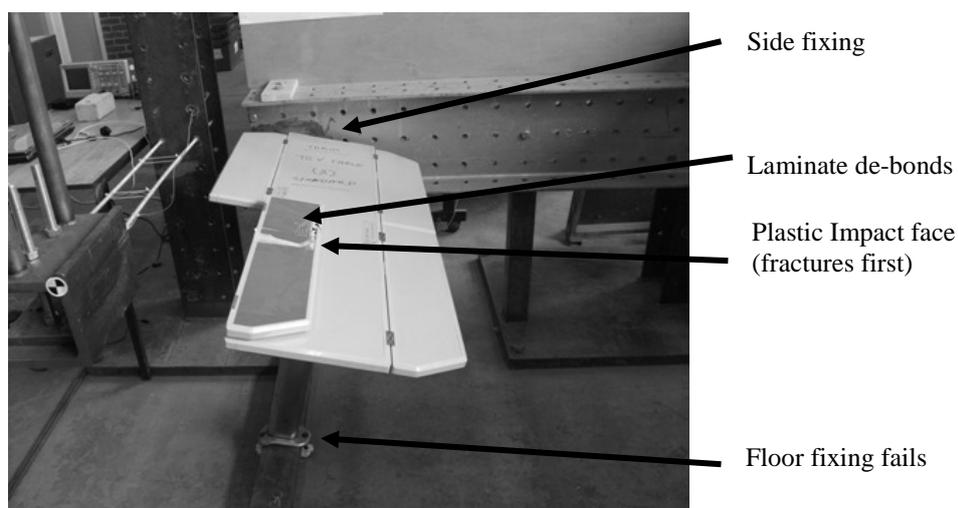
For the Standard Class design Table 2 design, the impulse lasted for about 3ms, and the corresponding velocity change was 1.21 m/s. Fig. 13 shows the load curve as a function of time. Soon after the pendulum struck the table, the Formica top moved upwards (debonding). Further examination showed that the front plastic edge failed first. The plastic then pushed the laminate outwards, causing it to debond (which is similar failure mechanism observed during quasi-static tests).

Fig. 14. Still Picture of Failed Table 2
