SOME PECULIARITIES OF CORROSION OF WHEEL STEEL

Summary. Corrosion mechanism and rate of different chemical composition and structural condition of wheel steel were investigated. It was shown that "white layers", variation in grain size and banding of wheel steel structure results in corrosion rate. Microstructure of steel from different elements of railway wheels after operation with corrosion was investigated. Wheel steel with addition of vanadium corroded more quickly than steel without vanadium. Non-metallic inclusions are the centre of corrosion nucleation and their influence on corrosion depends on type of inclusion. Mechanism of corrosion of wheel steel corrosion was discussed.

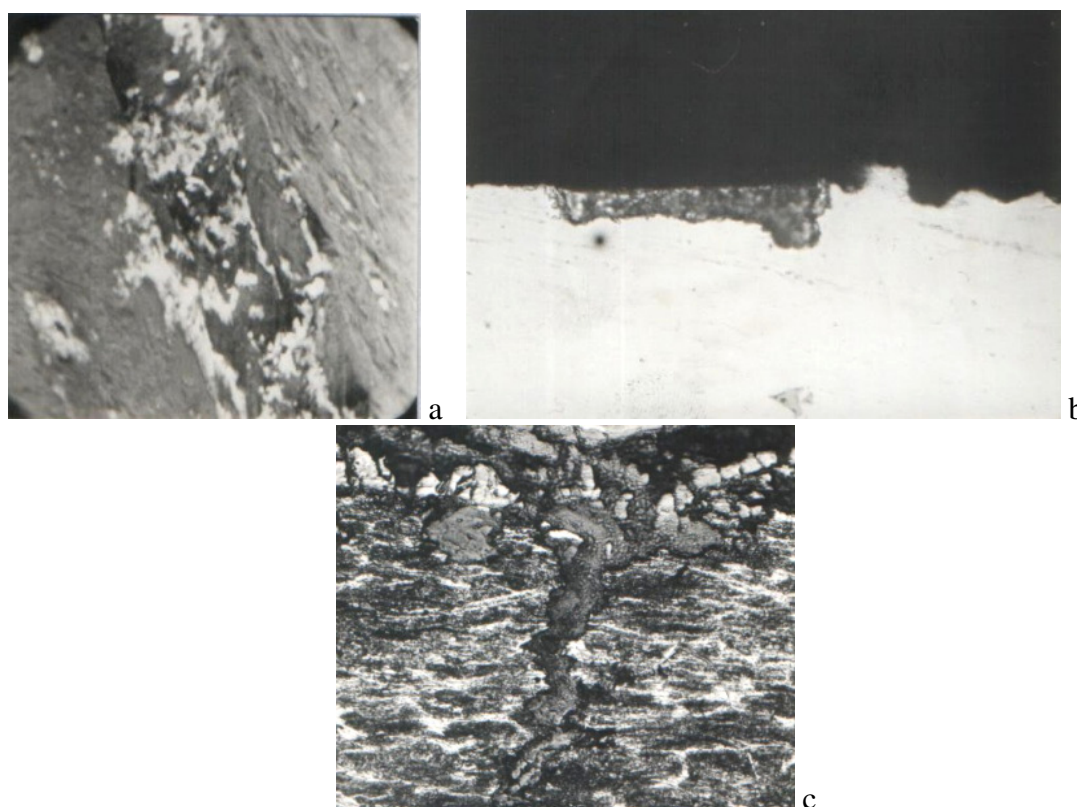
Examination of wheels 1 and 2 after operation was shown that many parts of their surface are covered by rust. Oxidation of steel takes place on tread, disk, hub. The particles of oxides were discovered by metallographic research (Fig. 1). Oxidation of steel started from surface and penetrated to considerable depth. Thus long operation of railway wheels allows show big sections of corrosion. Investigation of non-operated wheel 3 also was allowed small sections of corrosion in different parts of wheel. These zones are the ready centre of corrosion fracture during operation of railway wheels.

Fig. 1. Sections of corrosion in railway wheels 1: a – x100, b,c –x500

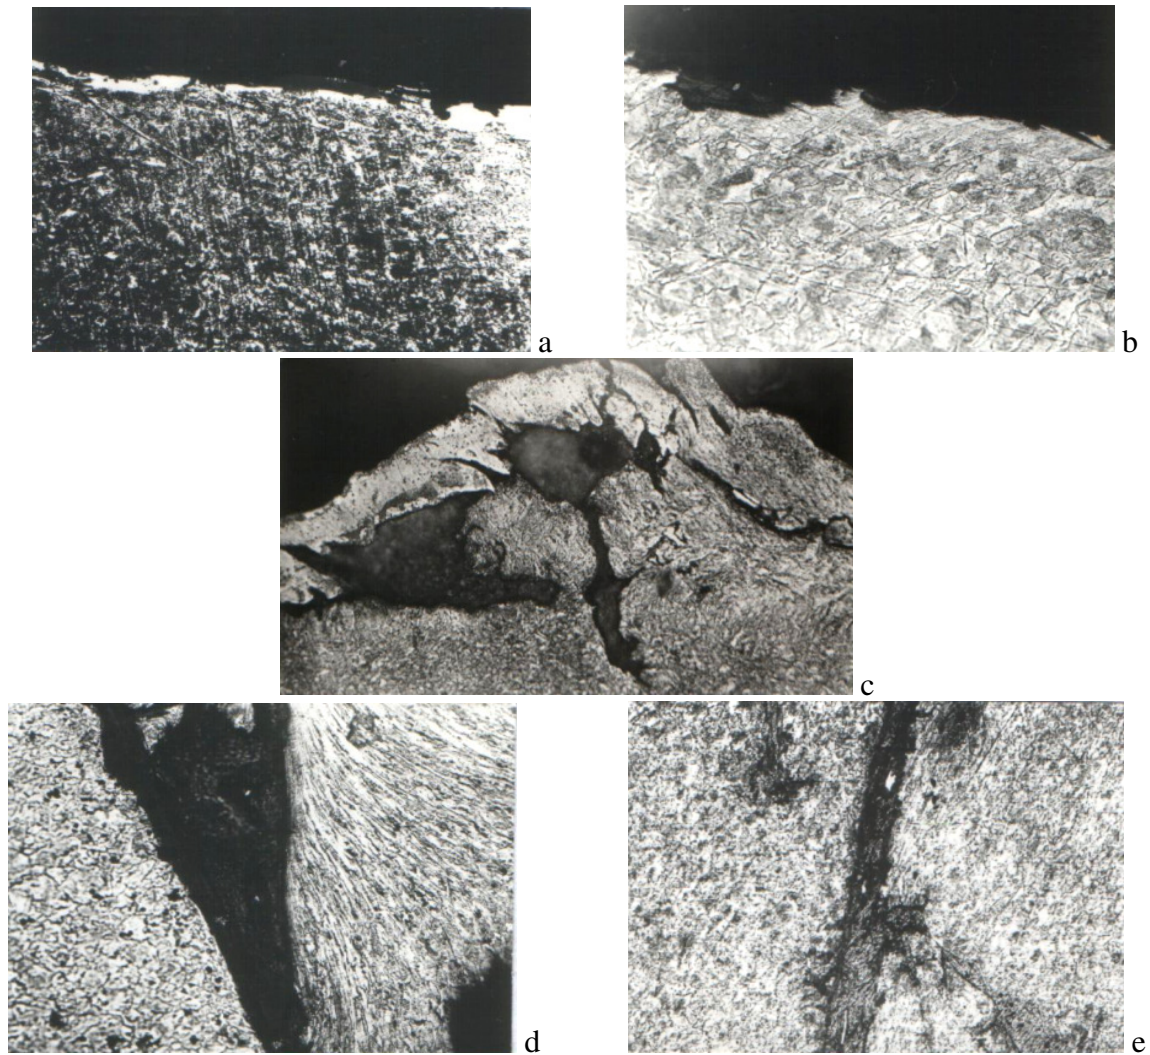
It is interesting the role of research of corrosion processes in the development of structural changes near tread during operation of railway wheels. Macrostructural analyses of wheel 1 with heavy worn-out tread were discovered fatigue-corrosion wear accompanied distorting of tread profile. Lots of cracks with corrosion of steel were shown from the slider to depth parts of wheel. Microstructure of wheel rim near tread is characterized by presence of deformed grains zone and also sections of “white layer” (Fig. 2) [2]. The depth of the “white layer” is 20-40 mkm, it has a break off character by flaking during operation of railway wheel. In cove zone the grains of steel are considerably elongated and refined (Fig. 2a), but the passage to tread grains are bigger, degree of their elongation is far and on the middle of tread their elongation is still less (Fig. 2b). By the passage from the middle of tread to the border of rim degree of grain elongation is increased again and stayed considerable. Character of structure of steel in this part of tread evidences about considerable flow of steel assisted to change of profile of railway wheel [2]. In roll zone the separations parallel oriented to tread with creaks were discovered (Fig. 2c). As a rule they are disposed on the boundary between

areas with different microstructure of steel and are divided zones of elongated and equiaxed grains. Roll took place by layers of metal which were deformed during shifting. In the time of shifting the brittle cracks were originated which promoted fracture of metal in layers. At the end of roll on the rim side lobes with strong deformed structure were disposed (Fig. 2d). There also are evidenced about lamellar mechanism of roll of metal from the middle part of tread to border of rim. Between these layers and also between roll metal and side of rim lots of cracks are shown. By the investigation of steel structure in the plane parallel tread the signs of turbulent flow of metal layers in roll zone were discovered (Fig. 2e).

Analyses of metallography investigation results allow to accept that structural changes happened near tread of railway wheel are accompanied by corrosion. Zones of corrosion fracture were discovered along section of rim in areas with strong deformed structure also in areas of “white layer” (Fig. 2a). By the roll formation on the side of rim when thin layers of steel are removed to side of rim and disposed one over another the areas with oxidated surface of steel are found in internal parts of rim (Fig. 2c, d) and they are arranged between layers of deformed metal (Fig. 2e). Evidently presence of large oxide particles promotes not only to local fracture of tread areas but also to heterogeneous development of structural changes in thin layer of metal.

Fig. 2. Sections of corrosion near tread of railway wheel 1 after operation: x500

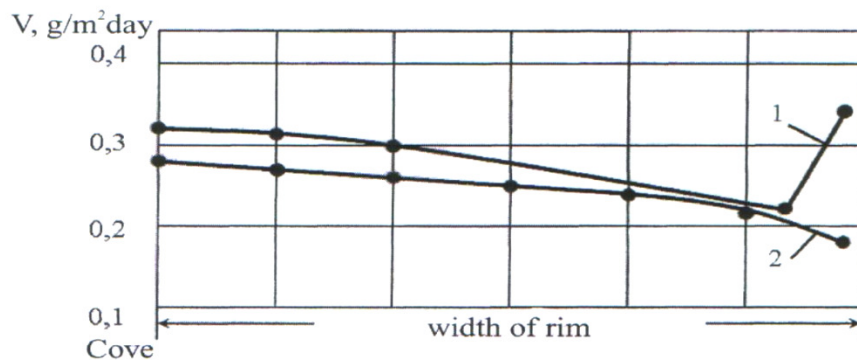
Structural changes happened near tread showed different behaviour of wheel steel by corrosion tests. Specimens from shabby wheels 1 and 2 were exposed to corrosion tests. Specimens from wheels 1 corroded at different rate which was decreased from cove zone along rim width and only near end of tread in the roll zone it again was increased (Fig. 3, curve 1). Thin parts of “white layer” corroded very quickly and were not discovered in structure of steel.

Fig. 3. Change of corrosion rate V of specimens of wheel steel from tread along width of wheels 1 and 2 rims

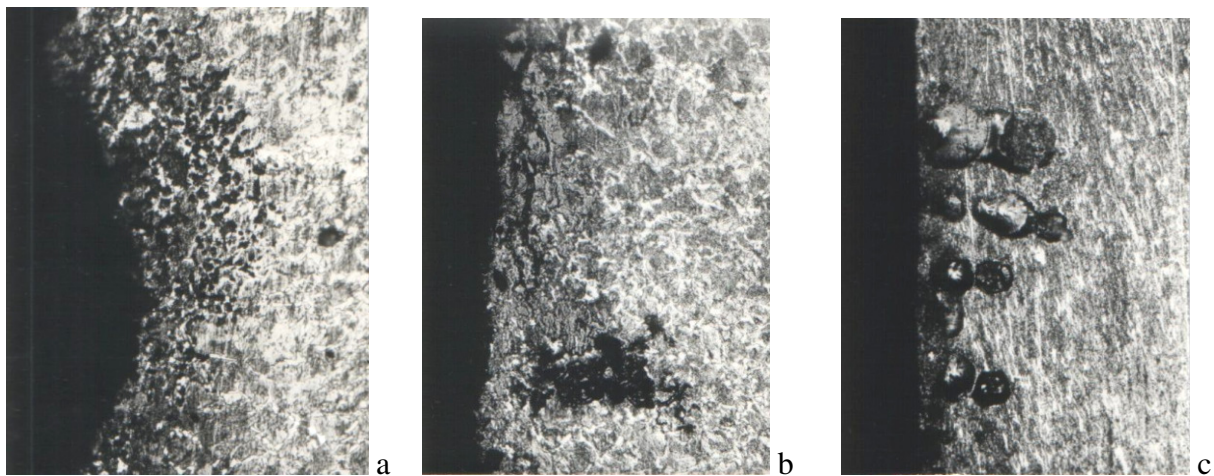
Change of corrosion rate and mechanism is obviously connected with change of character of plastic shear zone. In cove zone where grains are elongated and thin layer of steel was strongly deformed corrosion rate was maximum. Numerous small (< 20 mcm) oval corrosion centre of localized corrosion were discovered (Fig. 4a), which were penetrated to considerable depth. In the time of corrosion the layer of elongated grains almost fully disappeared. Maximum corrosion rate in the cove zone are explained by influence of plastic deformation created stresses in metal. In the middle of tread character of corrosion was changed (Fig. 4b). Along surface of specimens porosity corrosion film was formed and microcracks near oxides were discovered. Corrosion rate of specimens from the middle of tread and along to side of rim is essentially lower. In roll zone corrosion rate was increased again (Fig. 3, curve 1), and large pitting corrosion centres were discovered (Fig. 4c). Their average size was 0,6 mm. Increase of corrosion rate of wheel steel in roll zone is explained by influence of considerable plastic deformation and also by the presence of cracks between layers of rolling metal. Corrosion centres in roll zone are considerably larger than in cove zone. Thus heterogeneous plastic deformation along rim which took place during operation of railway wheels promotes to heterogeneous corrosion fracture of tread.

Fig. 4. Microstructure of wheel steel (wheel 1) after corrosion tests in different parts of tread along width of rim: x200

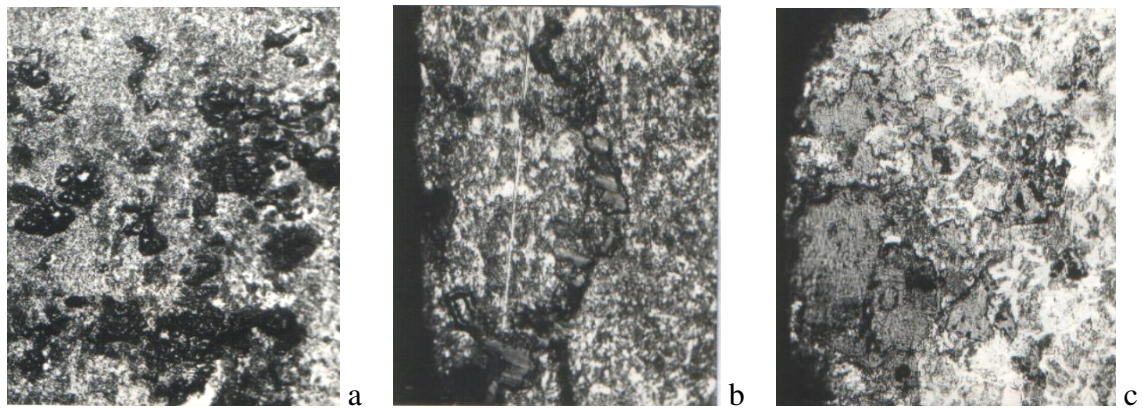
Specimens from shabby wheel 2 also were corroded with different rate which was monotonously decreased from cove zone along width of rim (Fig. 3, curve 2). "White layer" was pitting by pitting corrosion practically on all the depth (Fig. 5a). In areas with base structure of steel (pearlite + ferrite) and small zones of "white layer" corrosion started on the surface and penetrated deep into steel by cracks (Fig. 5b) or by compact front (Fig 5c). From the corrosion areas microcracks were penetrated into interface boundaries ferrite-pearlite and also by pearlite, which has well-developed interface boundaries ferrite-cementite.

Fig. 5. Microstructure of wheel steel (wheel 2) after corrosion tests in different parts of tread along width of rim: x400

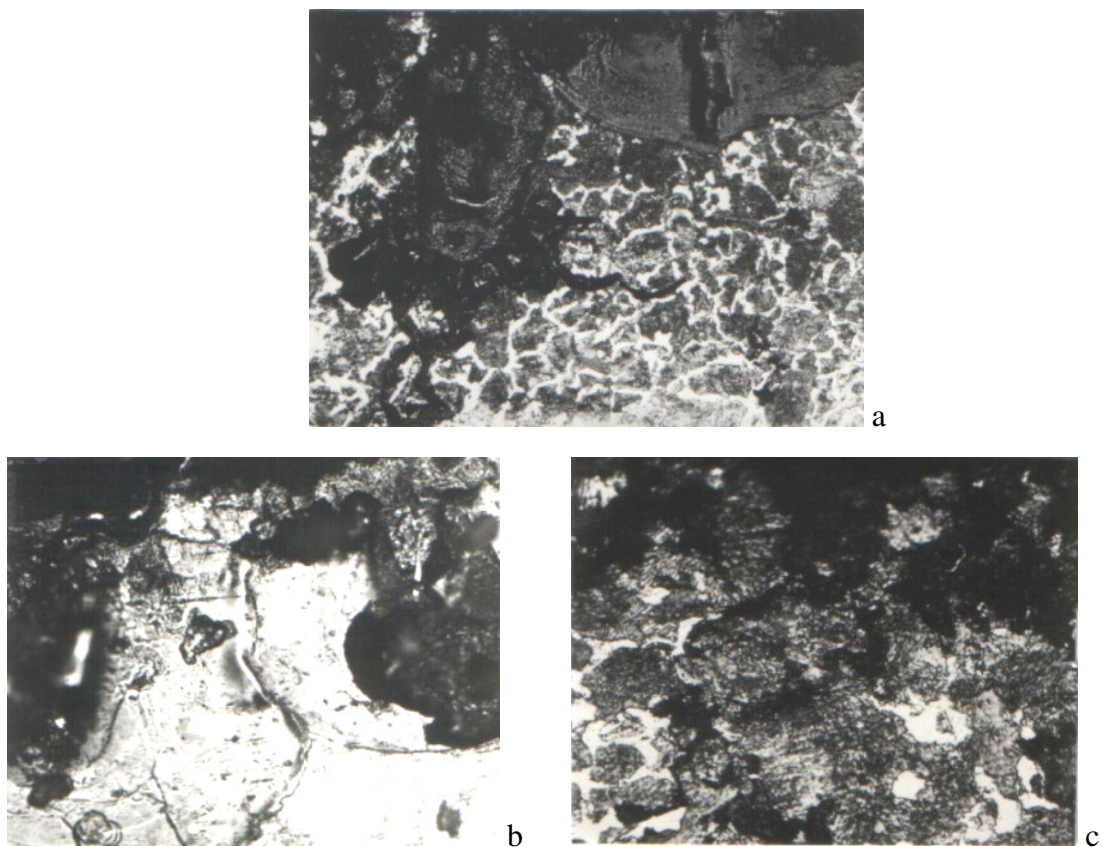
Corrosion of specimens from centre part of rims of wheels 1 and 2 took place by formation of large centres of oxidation of steel (Fig. 6a, b). Corrosion centres were formed on the surface of specimens and then were penetrated into depth of specimens and were grown by width to contact one another. Under corrosion in oxides and on the interface boundaries oxide-steel structural and phase stresses and microcracks were beginning. Sizes of corrosion centres in these cases are 1-2 mm. Corrosion rate of rim metal of wheels 1 and 2 possessed ferrite-pearlite structure are approximately the same and was higher than corrosion rate of steel from tread (Tabl. 2).

Metal disk corroded more quickly than metal of central part of rim (Tabl. 2). Corrosion process was spreading along pearlite areas (Fig. 6c), and also along ferrite-pearlite boundaries. Kind of corrosion damages of metal from rim and disk is different: in the first case small corrosion centres were discovered, in second case large corrosion centres were discovered. From corrosion centres intercrystalline cracks were spreading along pearlite and ferrite-pearlite boundaries. Corrosion rate of specimens from disk of wheel 1 was a little higher than corrosion rate of disk of wheel 2.

Fig. 6. Microstructure of specimens from centre part of rims of wheel 1 (a) and 2 (b) and also from disk of wheel 2 (c): a, c – x400, b – x200

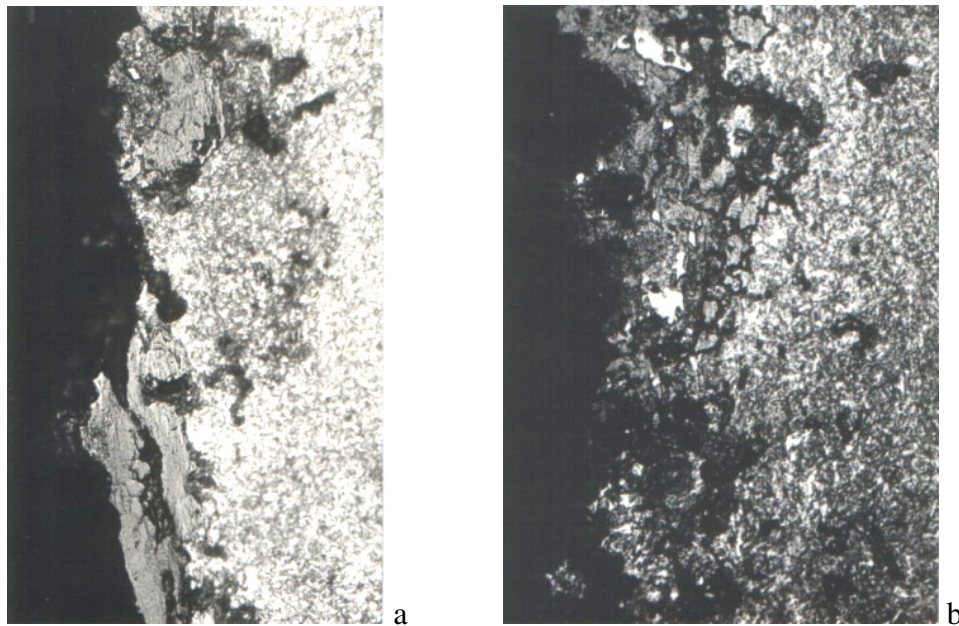
Corrosion of specimens from tread of heat treated wheels 3 and 4 (with addition of vanadium) having structure of sorbite of tempering had lamellar or film character. Specimens from centre part of rim of wheels 3 and 4 had the same character of corrosion (Fig. 7a, b). Brittle cracks were spreading from porosity oxides to steel. Steel with addition of vanadium corroded more quickly than ordinary wheel steel (Tabl. 2). It is known vanadium promotes to decrease of corrosion resistance of steel and influence of manganese is the same [1]. The tread after heat treatment corroded more quickly than tread after operation.

Fig. 7. Microstructure of surface of wheel steel specimens with addition of vanadium (a) and ordinary wheel steel (b) after corrosion tests: x200

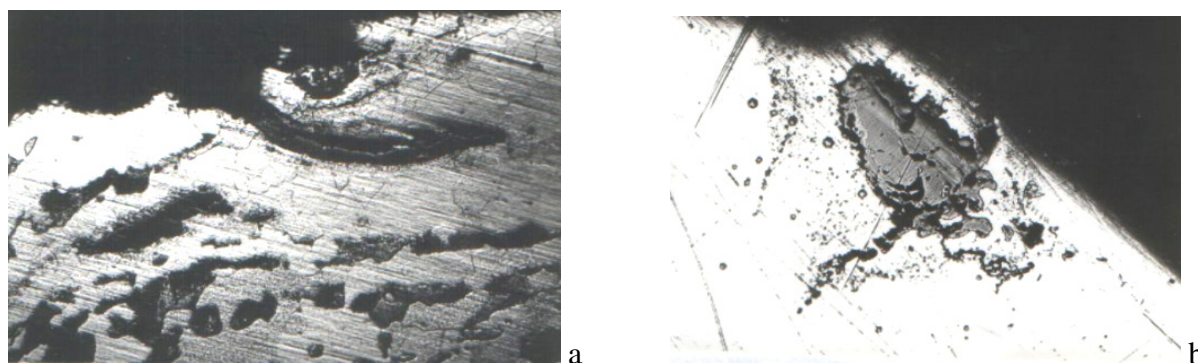
It is known that considerable thermal and deformational stresses causing by different physical-mechanical properties of non-metallic inclusions and steel matrix are excited near these particles [4, 5]. Stresses are formed on different stages of railway wheels production. Concentration of stresses promotes reinforcement of corrosion damage for all kinds of non-metallic inclusions. Especially it is displayed by application of external stresses. In our research the nucleation and localization of corrosion fracture of wheel steel was observed near different kinds of non-metallic inclusions in worn-out railway wheels and also in heat treated railway wheels (Fig. 8).

Fig. 8. Corrosion fracture of wheel steel near non-metallic inclusions: a - sulphide $(\text{Fe,Mn})\text{S}$, rim, wheel 2; b - oxide $\text{MnO}\cdot\text{Al}_2\text{O}_3$, tread, wheel 1; $\times 600$
