Technical University of Lodz

HYDROSTATIC DRIVE OF THE FERRY APPROACH BANK

Summary. The operating problems of the ferry approach ramp have been presented in the paper. The incorrect idea of approach bank drive system and abnormal operator acting, have been both the reasons of break-down and damage of a ferry terminal. The evaluation of the run of events and finding the reasons of the failure, have been possible thanks to the analysis of drives and control systems.

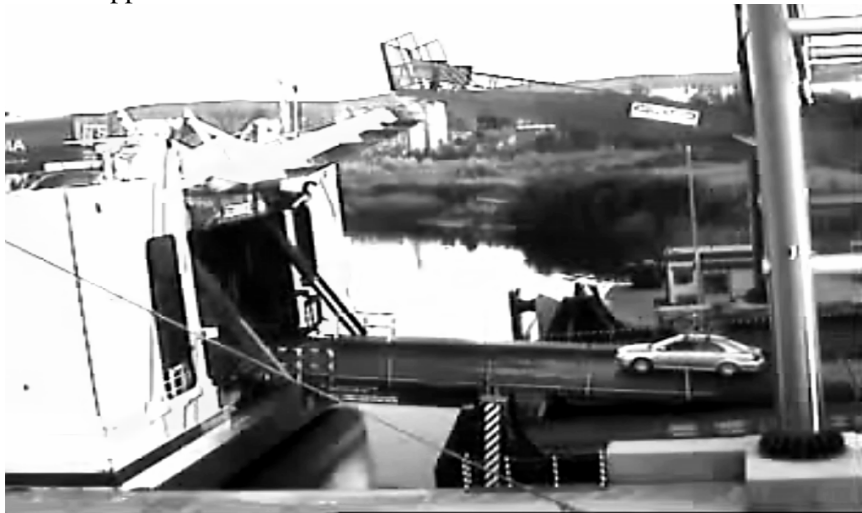
In the fig. 1, which is one of the frames from the film presenting the terminal operation, it can be seen that the requirement mentioned above is not respected by the ferry operators. To reduce the time they started to hoist the upper ferry ramp before finishing the movement of the approach bank of the terminal. At the beginning of expertise works it has been assumed as the main reason of the damage. This assumption was done because during the incident, earlier hoisting of the ferry ramp hooked up the not finally hoisted approach bank.

Fig. 1. Dangerous close proximity of the ferry ramp with the approach bank
Rys. 1. Niebezpieczne zbliżenie rampy promu do pomostu

On the basis of the operational film analysis it has been discovered that always in practice the hoisting of ferry ramp had begun before the ending of approach bank hoisting. It can be observed that the beginning of the ferry ramp hoisting took place when the position of the hoisted approach bank was about 40 – 56% comparing to its final destination. Usually it did not cause any failures however on the day of the accident when the ferry ramp came into collision with the being hoisted approach bank.

It was also recommended to use the close proximity sensors on the ferry ramp in case of the ferry ramp hoisting before ending the approach bank hoisting (which reduces the time of ferry loading of about 1 minute).
