## **IMPROVEMENT OF THE MECHANICAL PROPERTIES OF MOBILE PLATFORM STAINLESS CONSTRUCTION ELEMENTS**

**Summary.** Stainless steel could be treated as the main material used to construct various means of transport, including mobile platforms and tank trucks. An austenitic steel known as 316L steel (1.4401) has high resistance to atmospheric corrosion, natural waters, water vapor, alkaline solutions, and acids, even at elevated temperatures. This steel is weldable, although it is also prone to various types of welding cracks. Many factors influence the quality and mechanical properties of a joint. The most significant of these is the appropriate selection of welding parameters, which should be determined precisely and separately for each type of sheet, depending on its thickness and geometric features. The aim of the present article is to study the influence of main TIG (Tungsten inert gas) welding parameters on the creation of proper joints used in the construction of mobile truck platforms or tank trucks. The proper selection of parameters enables the production of welds with good functional properties. A novelty of this article is the proposal to weld each layer of a thick joint wi

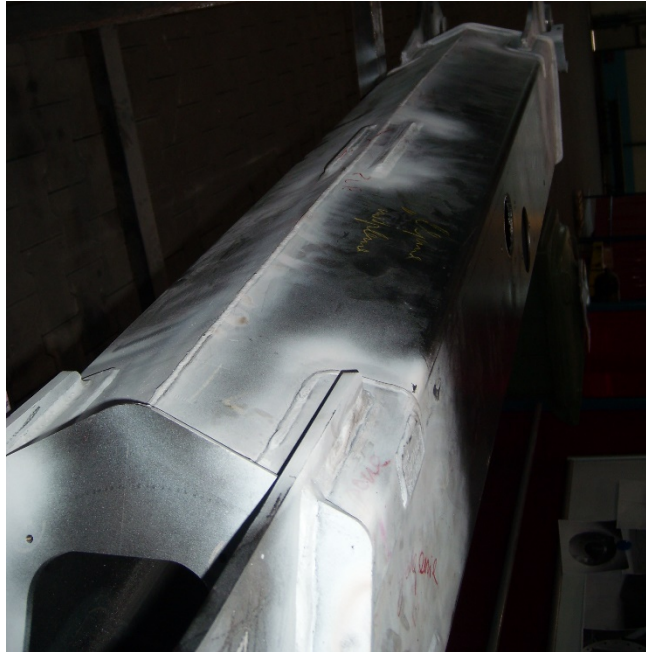
Fig. 1. Visible corrosion in the central part of the mobile platform (specific means of transport)

steel elements in mobile platforms and tank trucks. Corroded elements reduce the load capacity or anchoring of the structure, which reduces the safety of the work performed, especially at high altitudes. Fig. 1 shows an example of highly loaded elements in a mobile platform that should have higher corrosion resistance.

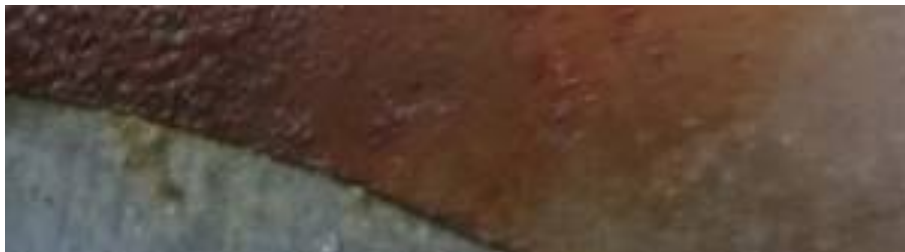
Fig. 2. Element of the mobile platform with various levels of corrosion intensity

Fig. 2 is a detailed view of the corrosion effect of the platform structure element after a long period of operation. Such corroded elements lose their required mechanical properties.

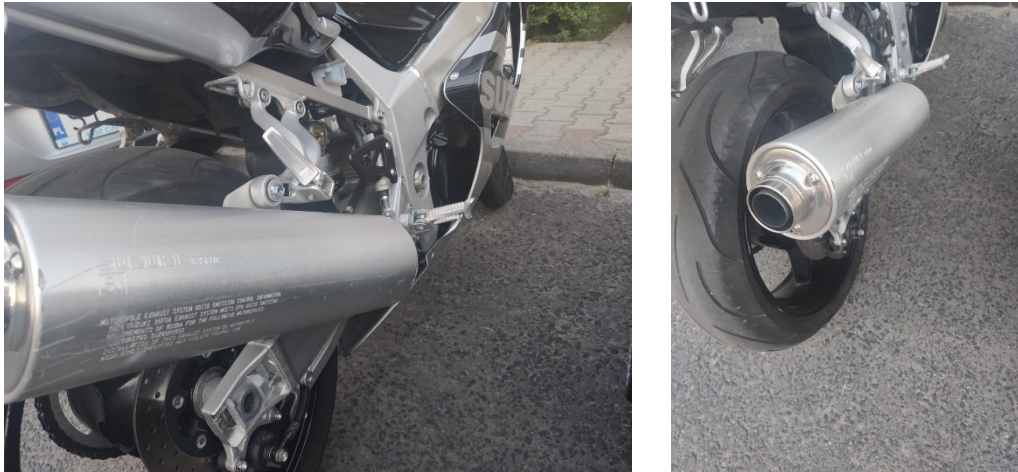
Fig. 3. A motor vehicle end muffler tip made of stainless steel

316 L steel is applied for various thin-walled construction (thickness = 2 mm) in automotive transport. An example of an austenitic element in an automotive structure is shown in Fig. 3.

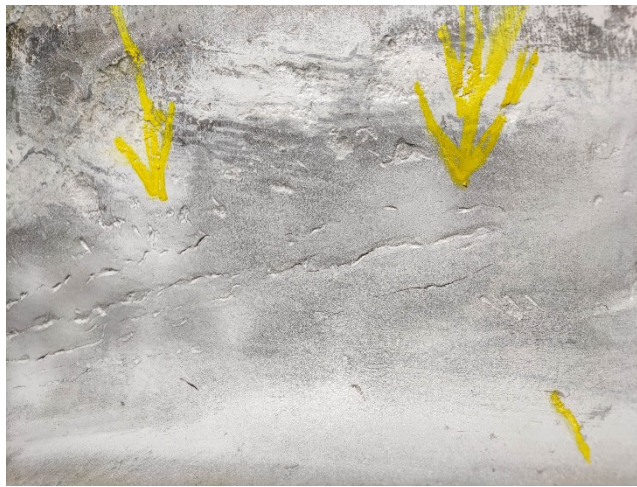
Fig. 4. Cracks in a weld

Research on mobile platforms shows that cracks in joints (Fig. 4) are one of the main causes of serious failures of these structures. Previous articles [14-16] present examples of damage to mobile platforms as a result of improperly performed welds.

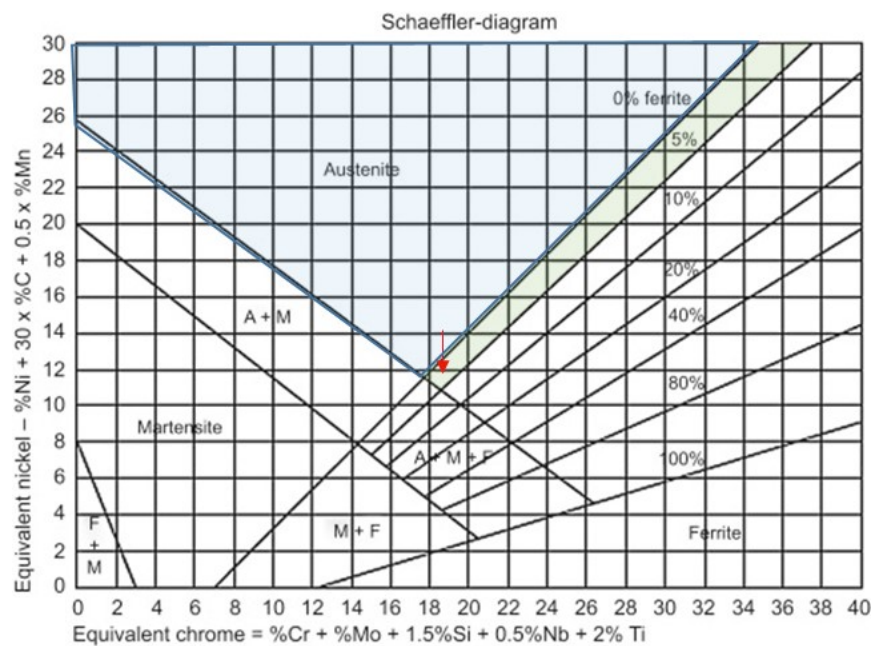
Fig. 8. Schaeffler diagram with marked areas of austenite (blue area) and austenite with low ferrite content (green area)

To maintain a 100% austenitic structure, a filler material with increased carbon content might be proposed, because C is austenite former element (Fig. 8). However, it is recommended, as increased carbon content in the weld results in the formation of carbides, which is less advantageous than the presence of a low delta ferrite content. As a result of correctly chosen welding parameters, ferrite delta is fine-grained. An increase in the welding of linear energy promotes the growth of ferrite grains, which leads to the formation of cracks (as observed in S1, S2, S3, S6, S8, S9, S10; Table 3). The last stage of the experimental approach was to measure the hardness HV in the central part of the weld. The tests were realized as usual for S4, S5, and S7 because these specimens did not have any welding defects. Very often, the tensile strength tests described in the literature, in combination with non-destructive tests, are the main criterion for qualifying materials and technologies for use in the construction of means of transport.

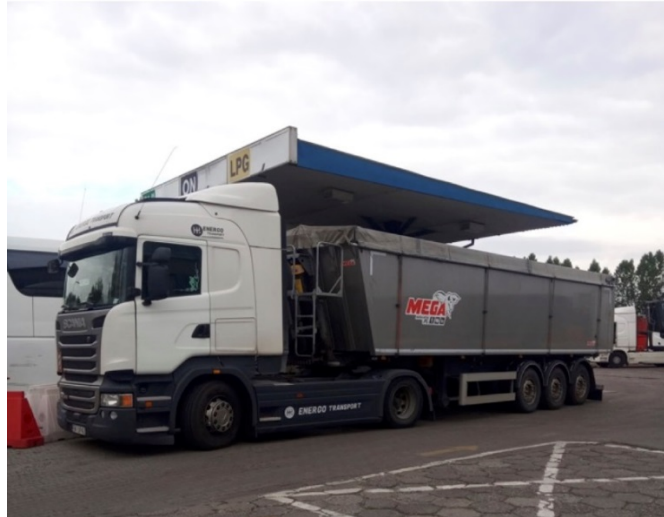
Fig. 10. A vehicle with highly loaded elements of a tipper made of austenitic steel

The results presented in the previous chapter indicate that the two-phase structure connections made with low linear energy (below 1.2 kJ/mm) were of good quality and were not susceptible to hot cracks. The connections were characterized by good mechanical properties, UTS, and relative elongation. So, we expect an increase in interest in austenitic steels for the construction of safe structures in the automotive industry. Until now, in the welding of austenitic steels, it was believed that the most important task was to obtain a joint with good corrosion resistance without cracks and other welding defects. However, this article shows that the choice of welding parameters for each layer in the thicker joint has an impact on the mechanical properties. It has a profound impact on the proper exploitation of means of transport in mobile platforms, tank trucks, and dump trucks (Fig. 10).
