Jarosław SPYCHAŁA, **Marek SZCZEKALA, Mariusz ŻOKOWSKI***
Air Force Institute of Technology, Division for Aero-engines
ul. ks. Bolesława 6, 01-494 Warszawa
Corresponding author. E-mail: Mariusz.Zokowski@itwl.pl

DIAGNOSIS OF THE JET-PROPELLED ENGINE BY VIBRATION ANALYSIS

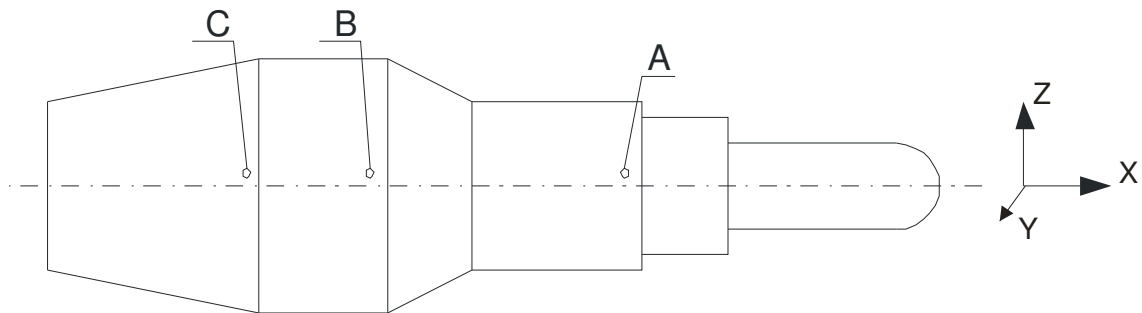
The measuring system consist of: card A/C with loading amplifiers and the piezoelectric sensors of vibrations. The vibrations pick-up placed on the cage of the jet-propelled engine, see Fig. 1. In order to analyze of signals in band 0 to 10000 Hz was prepared the software in the environment LabView.

Fig. 1. Points of fixing piezoelectric vibrations sensors on the cage of the engine
Rys. 1. Punkty mocowania czujników przyspieszeń na korpusie silnika

All finished stages were finished with measurement vibrations the cage engine with using the sensors of vibration in points A, B and C situated near planes: I, II and III bearing support of the engine, so as it was showed on Fig. 1.

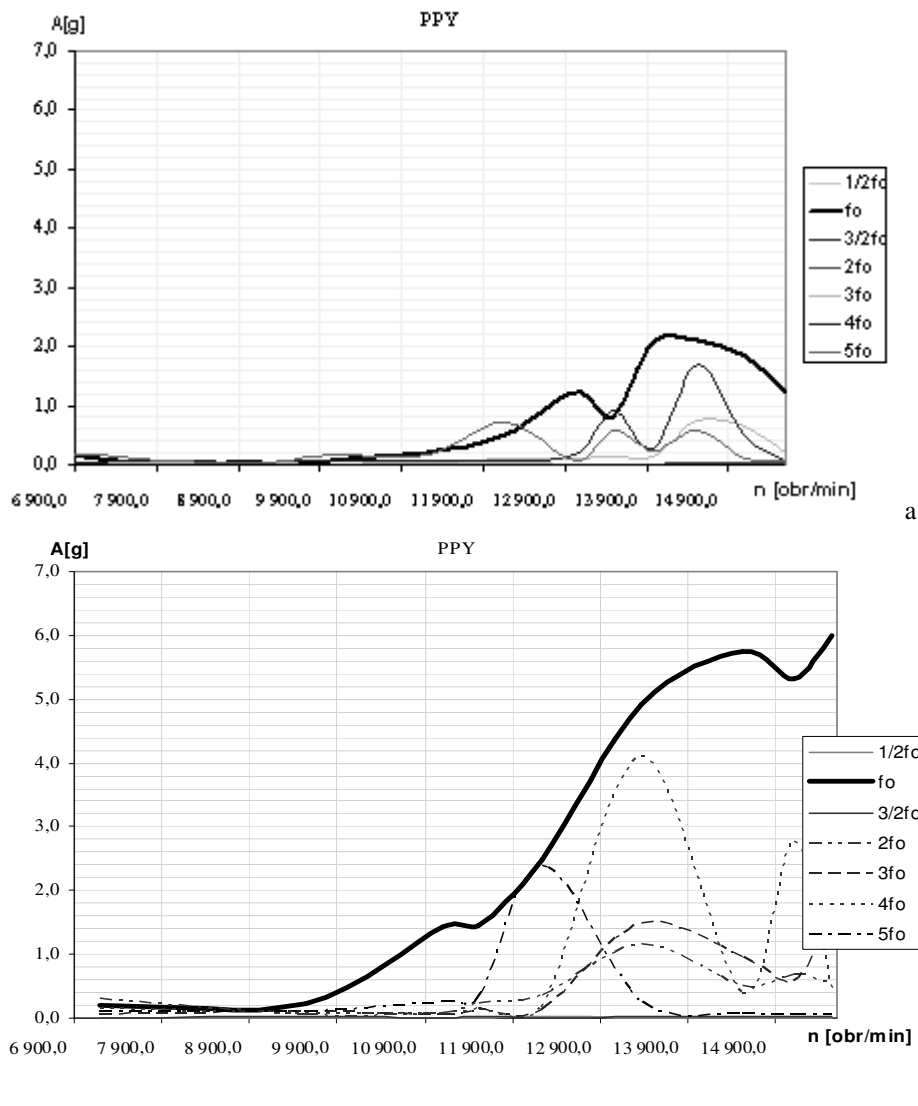
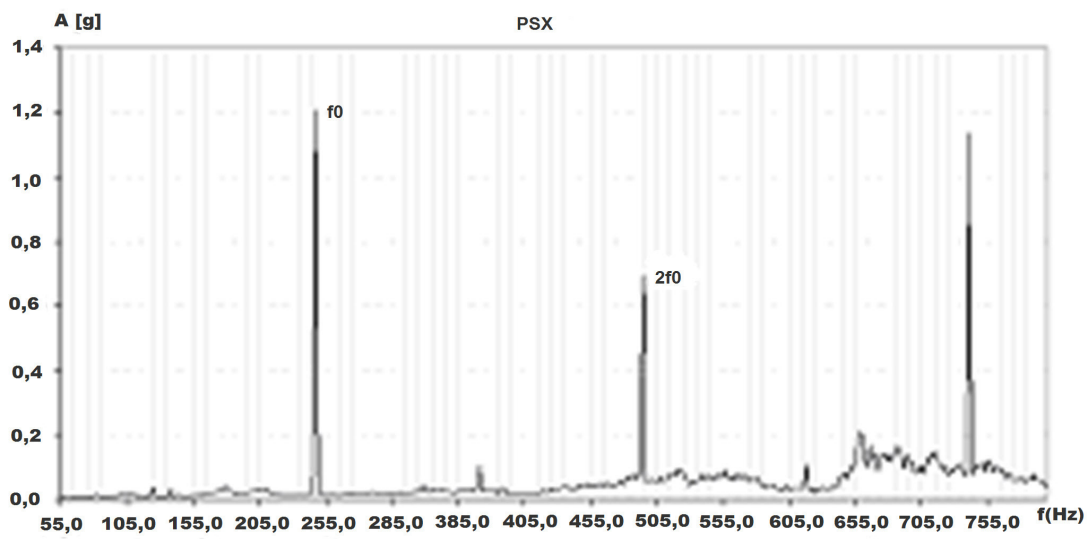
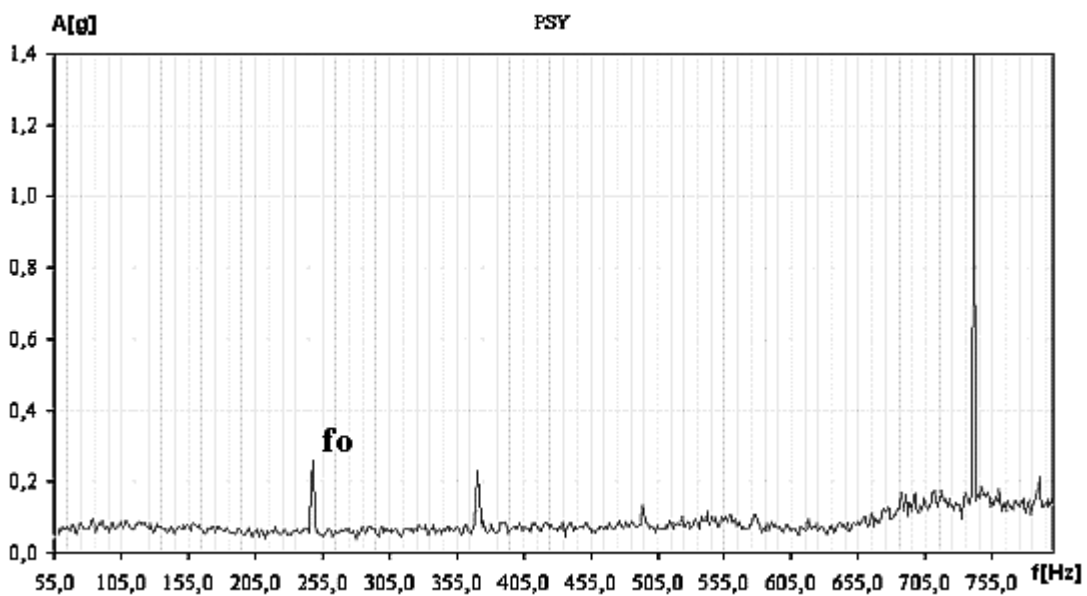
▪ unbalance of rotary element introduced in the last stage, Fig. 2;

Fig. 2.   Controlled unbalance the turbine 1000 [gmm]
Rys. 2.   Kontrolowane niewyważenie turbiny wynoszące 1000 [gmm]

▪ the misalignment and/or the backlash of the shaft (indirectly), Fig. 3. The central support was marked as PSX, PSY in direction 0x and 0y axis respectively;

Fig. 3.   Vibration spectrum showed unbalance of shaft according to the condition ($2f_{oPSX} > 0{,}75 * f_{oPSY}$)
Rys. 3.   Widmo drgań obrazujące niewyważenie wału zgodnie z warunkiem ($2f_{oPSX} > 0{,}75 * f_{oPSY}$)

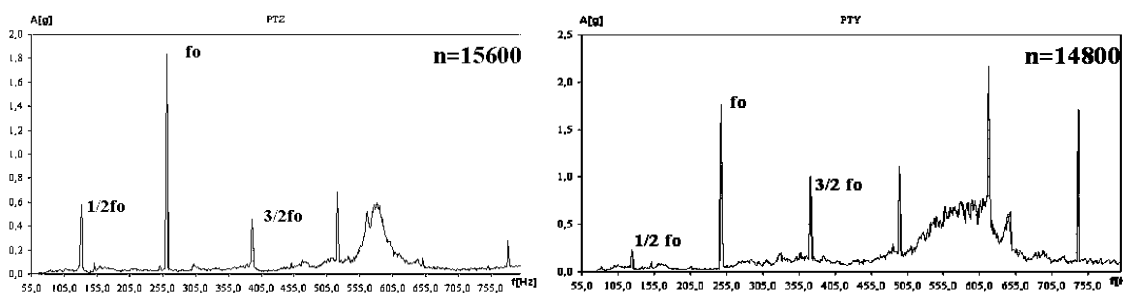
- subharmonics and their multiplicity, Fig. 4. The half of the value of rotary frequency and her multiplicity can indicate on backlash in the case of the bearing and the instability of bearing or his bracket;

Fig. 4.   Vibration spectrum with subharmonics and their multiplicity turns of shaft
Rys. 4.   Widmo drgań z harmonicznymi prędkości obrotowej

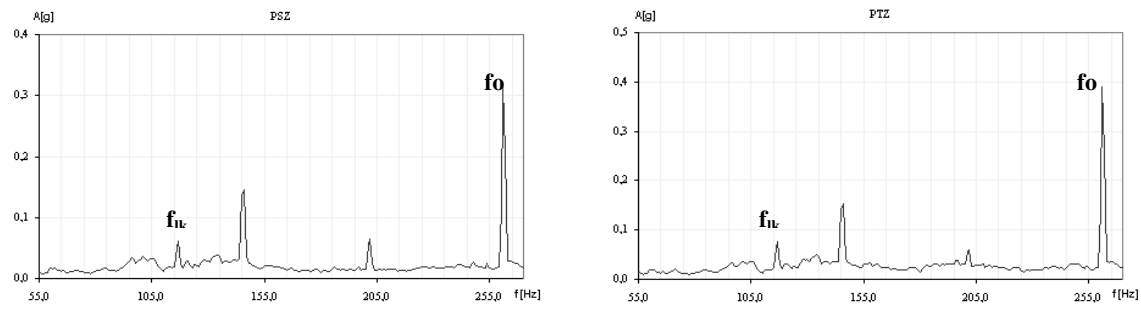
▪ elaboration of the rolling bearing elements, Fig. 5;

Fig. 5.   Vibration spectrum with showed characterized frequency of bearing cage f_{lk} near rotary 15600 r.p.m.
Rys. 5.   Widmo drgań z widoczną częstotliwością obudowy łożyska f_{lk} w pobliżu prędkości obrotowej 15600 obr/min

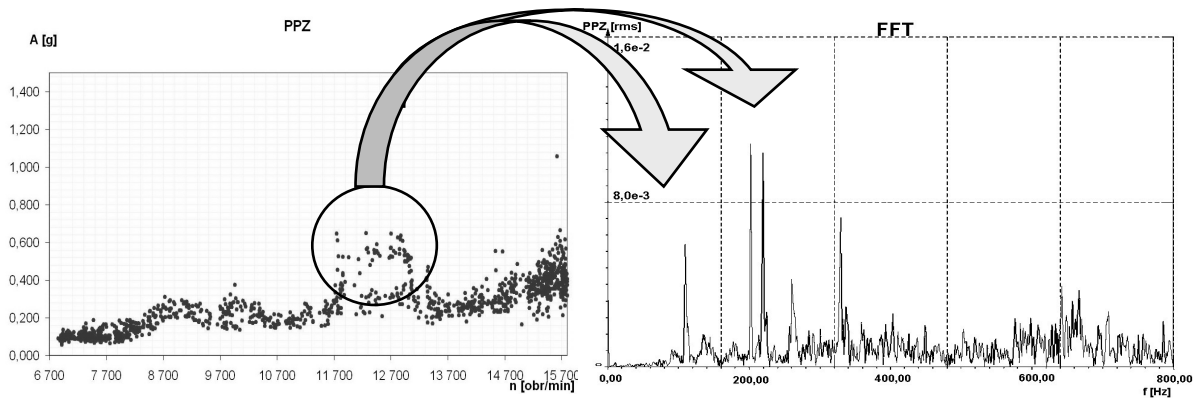
▪ inappropriate working of the mobile (whirling) elements of motor units, Fig. 6;

Fig. 6. Instability of the levels amplitudes of the motor units
Rys. 6. Niestabilność poziomów amplitudy skrzynki napędów agregatów

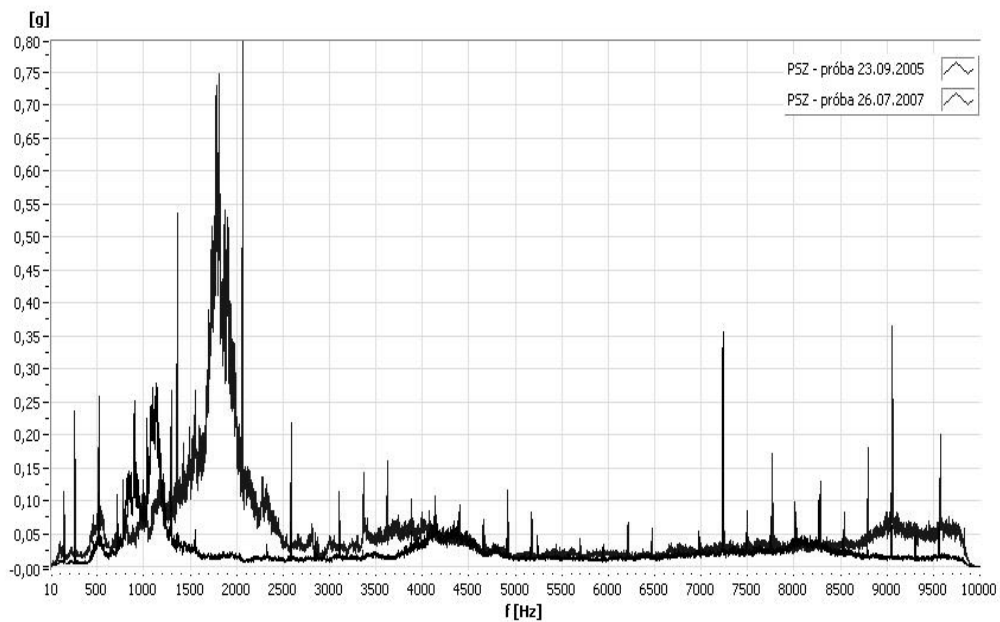
▪   changes in the observed resonances of structure, Fig. 7.

Fig. 7. Change in the observed resonances of the structure
Rys. 7. Obserwowane zmiany w rezonansie struktury silnika
