CRASH SAFETY OF A TYPICAL BAY TABLE IN A RAILWAY VEHICLE

Summary. Increasingly, urban and high speed trains are incorporating tables (workstations) as common railway vehicle interior furniture because passengers prefer seating by bay tables. Among table design characteristics, the most challenging is meeting crashworthiness requirements. Past accident data and sled test results have shown that in the event of railway vehicle frontal impact, occupants located in the bay seating are exposed to chest and abdominal injuries upon contact with tables resulting from secondary collision. In some cases tables have tended to be structurally weak; they easily detach from the side walls and/or floor mounting. Subsequently these become unguided missiles that strike occupants, resulting in injuries.

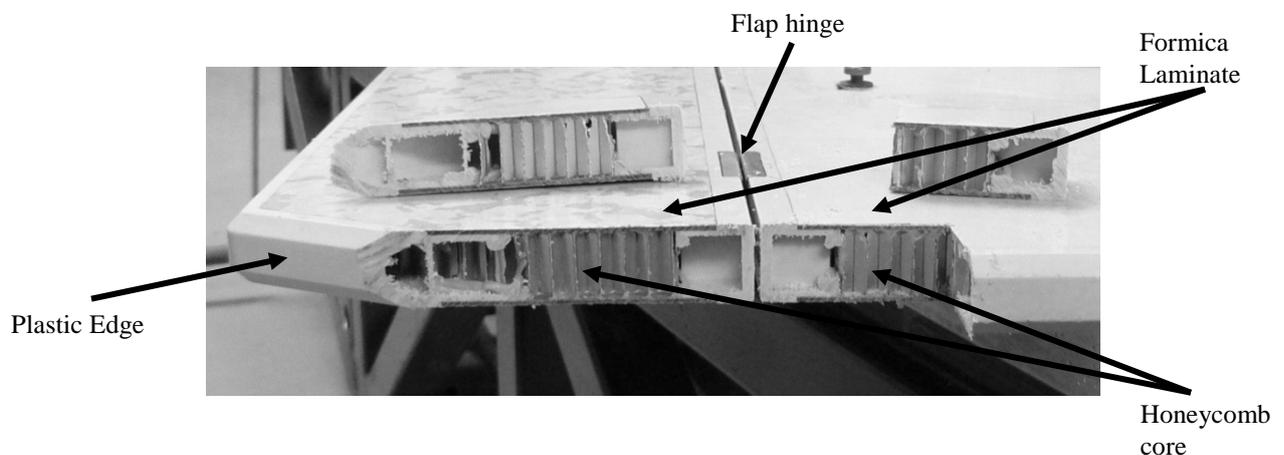
Fig. 5. Interior Structure of High Speed Train TGV Table
Rys. 5. Struktura wewnętrzna stołu z pociągu TGV

The table top (which is the main impact component) was made of a composite comprising an aluminium honeycomb core sandwiched between Formica laminates, while the edges were made of thermoplastic. It was observed that First Class and Second Class tables were the same in terms of the materials used to construct them. The shape was similar, but differed in geometrical dimensions of the table top. The former was larger.

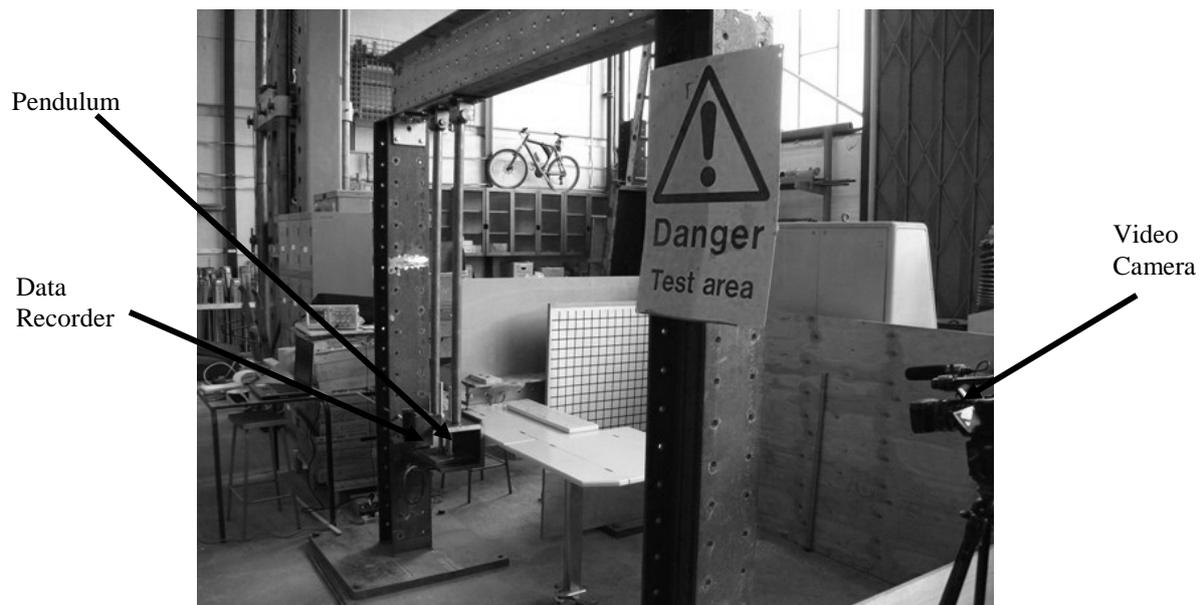
Fig. 7. Test Configuration (First Class TGV Table)

In all cases, the table top was impacted on the edge using a rigid metal pendulum as shown in Fig. 7 below. For the first two tests (SIBE 6/1 and SIBE6/2), the inner flap (close to the side fixing) was impacted, while the outer flap was impacted in the third test (SIBE 6/3).

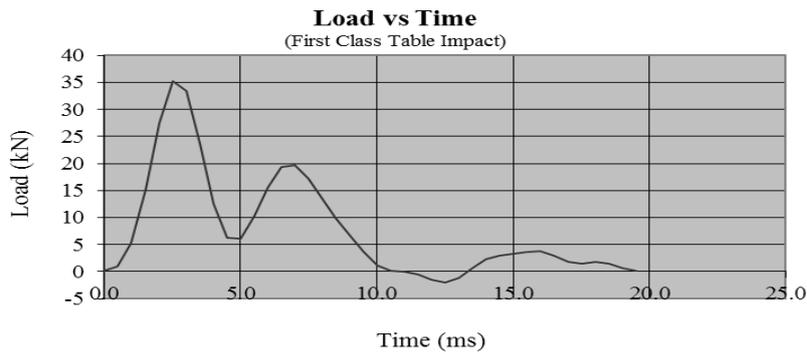
Fig. 9. Impact Characteristics of the TGV First Class

For the First Class table design, the impulse lasted for 10 ms, and the corresponding velocity change was 3.56 m/s. Fig. 9 shows the load curve as a function of time. Fig. 10 shows the frame from the video footage just after the pendulum struck the table. Soon after, the Formica top moved upwards (de-bonding). This failure mechanism is similar to the one observed during quasi-static tests of the table parts (see Section 3.1.1).

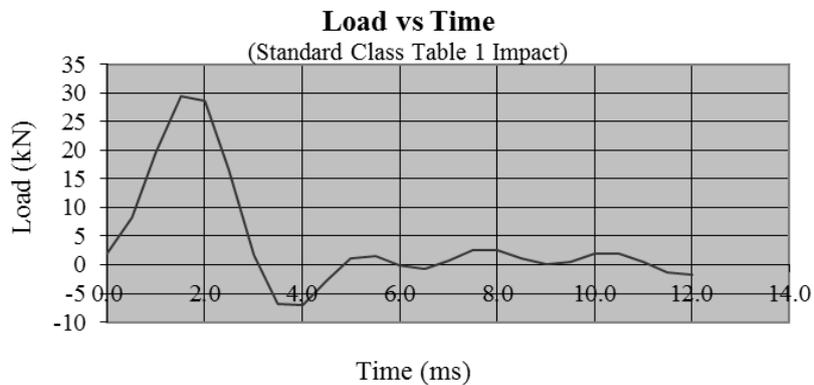
Fig. 11. Load Impact Characteristics of the TGV Second Class Table 1

For this first Standard Class table design, the impulse lasted for 3ms, and the corresponding velocity change was 1.32 m/s. Fig. 11 shows the load and energy curves as a function of time. Upon impact, the aluminium side fixing webs sheared off, resulting in the table falling while hinged about the floor fixing. Subsequently, both the floor plate and the bolt on the side of impact collapsed under tension. Hence the table fell as shown in Fig. 12. The impacted flap remained intact.

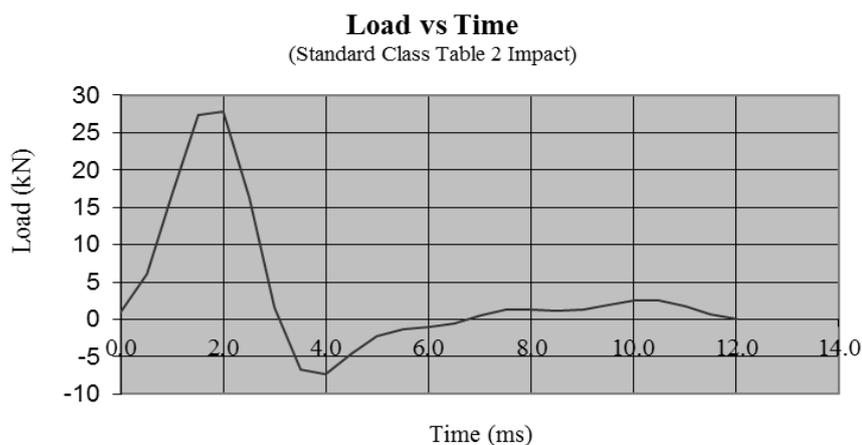
Fig. 13. Impact Characteristics of the TGV Second Class Table 2
Rys. 13. Charakterystyka obciążenia w czasie dla stołu 2 w wagonie TGV klasy drugiej

For the Standard Class design Table 2 design, the impulse lasted for about 3ms, and the corresponding velocity change was 1.21 m/s. Fig. 13 shows the load curve as a function of time. Soon after the pendulum struck the table, the Formica top moved upwards (debonding). Further examination showed that the front plastic edge failed first. The plastic then pushed the laminate outwards, causing it to debond (which is similar failure mechanism observed during quasi-static tests).

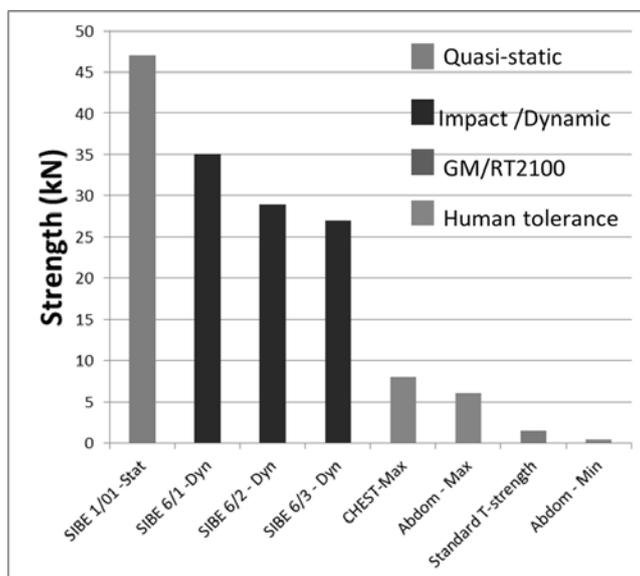
Fig. 15. Table Strength vs Human Tolerance
Rys. 15. Zestawienie siły z ludzką tolerancją

Both quasi-static and dynamic tests have shown that in the event of an occupant colliding with a bay table, the tested tables have a capability of developing resistive forces ranging from 27.4 kN to 47.6 kN. Such loading is far higher than the 0.5 kN to 6 kN range for injury tolerance of abdominal organs and 8 kN tolerance of the chest. Fig. 15 shows the comparison. The resistive forces may not be justifiable even though railway vehicle standards require a minimum resistive horizontal load of 1.5 kN [6].
