defects of joints of conveyor belts; simulation of failures;  
lifetime prediction

## **ANALYSIS OF RELIABILITY PARAMETERS OF CONVEYOR BELT JOINTS**

**Summary.** In the article was found the causes defects vulcanized joints based on analysis of operating of conveyor belts, given the physical and mathematical model of failure joints. Measures have been developed to improve the reliability of the joints of conveyor belts.

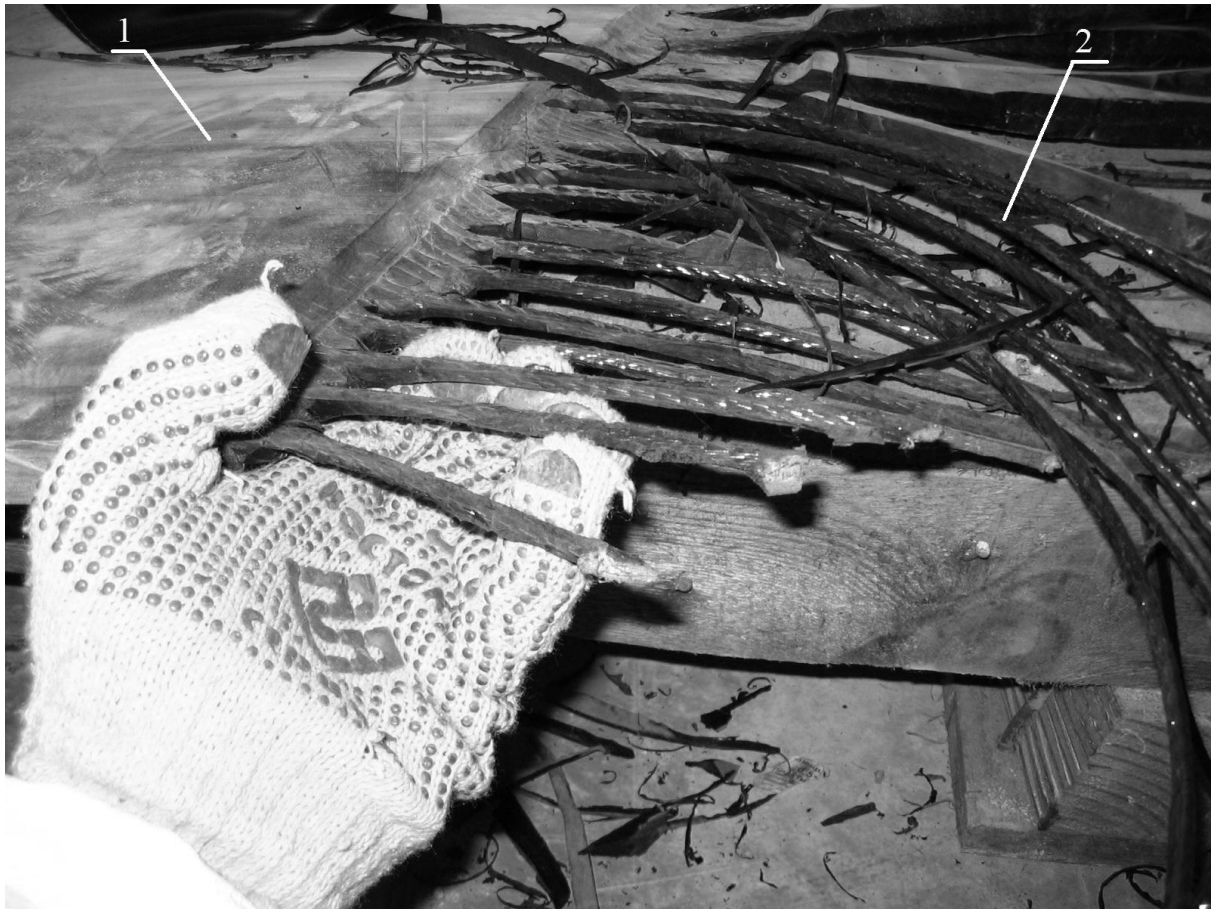
Fig. 1. General view of conveyer belt failure on Joint-Stock Company "Altyntau Kokshetau": 1 - conveyer belt; 2 – rope

Рис. 1. Общий вид выхода из строя конвейерной ленты на АО «Алтынтау Кокшетау»: 1 – конвейерная лента; 2 - трос

Reliability and efficiency of mining conveyors depends to a great degree on vulcanization defects of the conveyor belt joints [1]. It was proven by Veksler G.Z. in his work that joints are the weakest component of the conveyor belts [2]. Consequently it is critical technological and scientific challenge to increase reliability and durability of the mining conveyor belt joints. Defects and failures of the joints tend to hamper normal operations and efficiency of manufacturing process, increase consumption of conveyor belts, operational complexity, and cost of transportation. The open-pit mining downtime caused by damaged and broken belt joints is around 21-22%. Joint violations cause about 30% of wear in the conveyors transporting lumps. Operability of vulcanized joints varies very widely in the same operating conditions: in some cases it is close to the main belt operability, in others violations occurs after several weeks and sometimes even days of work (fig. 1, 2).

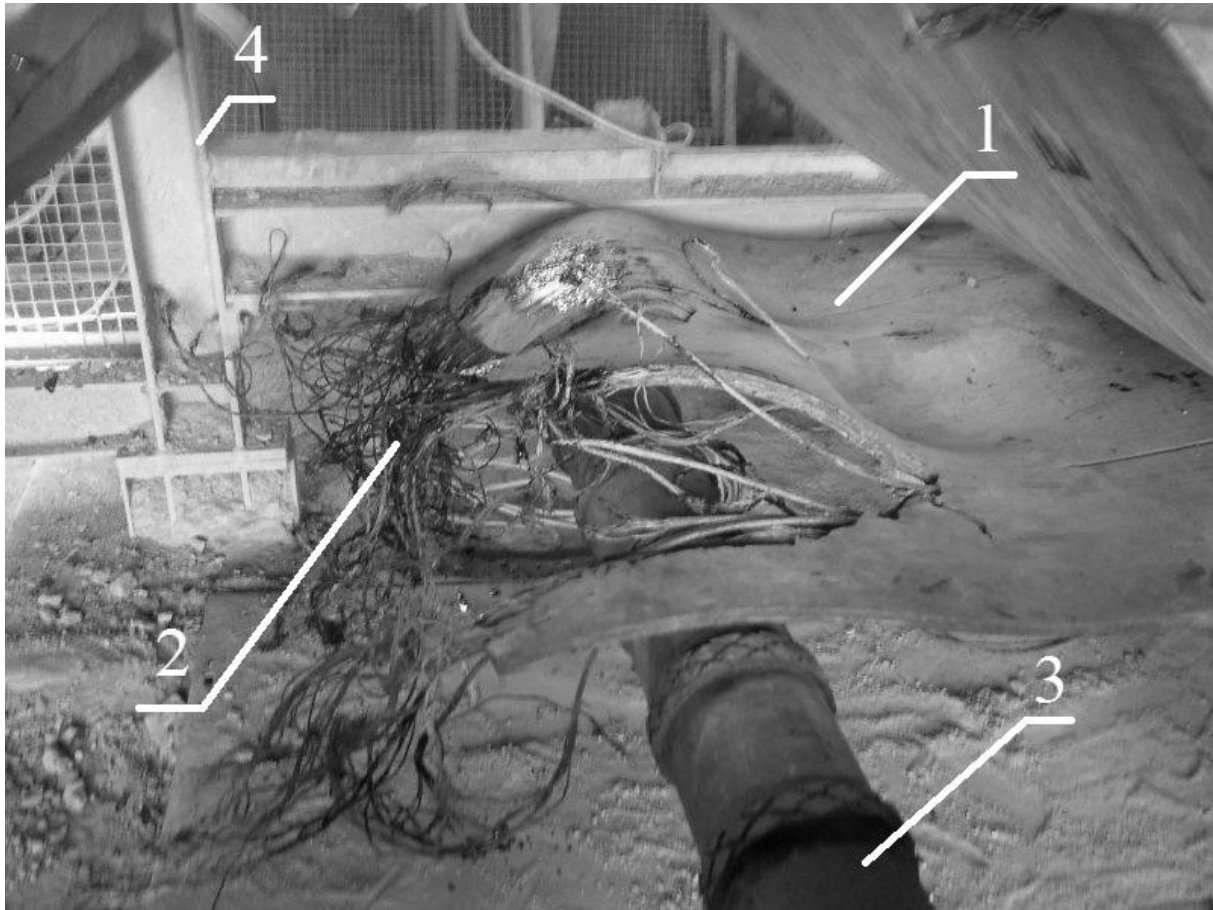
Fig 2. Fragment of break of connection of conveyer belt with steel rope cords: 1 – conveyer belt; 2 – broken connection; 3 – roller bearing; 4 – pillar of enclosure

Рис. 2. Фрагмент разрыва соединения резинотроссовой конвейерной ленты: 1 – конвейерная лента; 2 – место разрыва соединения; 3 – роlikоопора; 4 – стойка ограждения
