Artur BLUM*, **Kamil HAREMSKI**
AGH University of Science and Technology
Al. Mickiewicza 30, 30-059 Kraków, Poland
**Corresponding author. E-mail: art_blum@agh.edu.pl*

EMERGENCY DIAGNOSTICS OF LOAD-CARRYING STRUCTURES INTO THE WORKS TRANSPORT

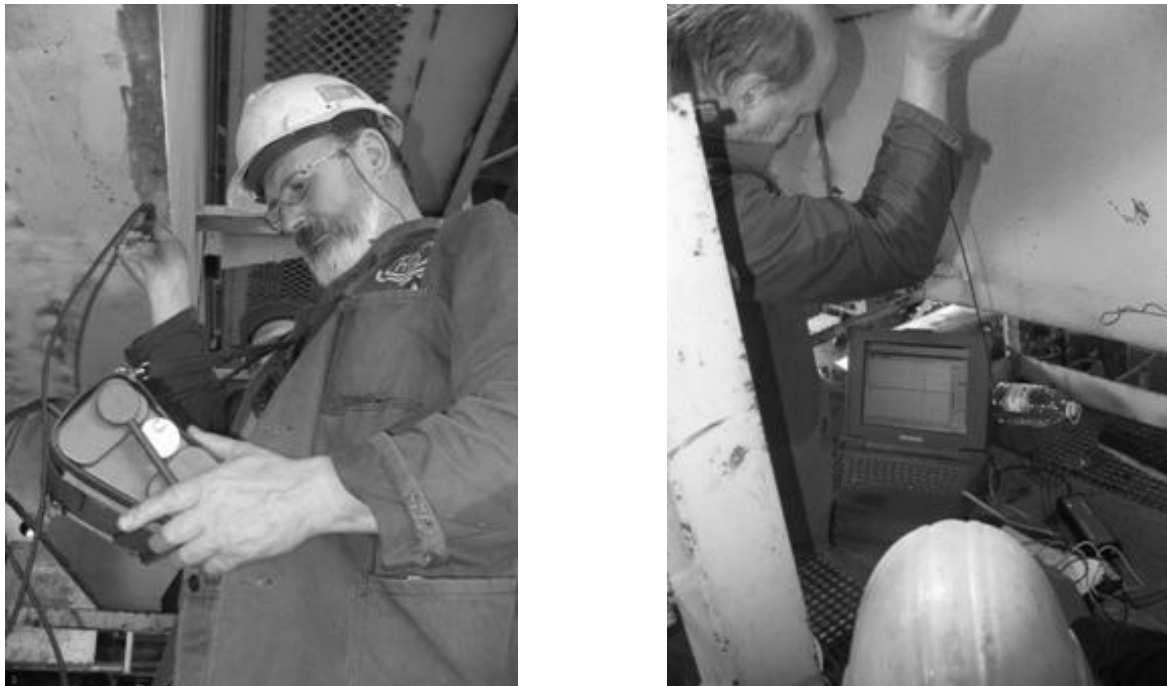
Fig. 1. Investigation with flaw detector USM-35M (left) and flaw detector USLT 2000I (right)
Rys. 1. Badanie defektoskopem USM-35M (po lewej) oraz defektoskopem USLT 2000I (po prawej)

Initial localization of discontinuity were investigated by ultrasonic research with flaw detector USM-35S with dual converter head MSEB-4-4. Further in those regions principle not destructive research were made with usage of flaw detector USLT-20001\I with miniature sending-receiving head G15MN.

Figure 1 presents pictures of diagnostic investigation of crane bridge which scheme is on fig. 2. Research results of s5 zone (according to fig. 2) with mathematical description of signal with usage of FFT were shown on fig. 3.

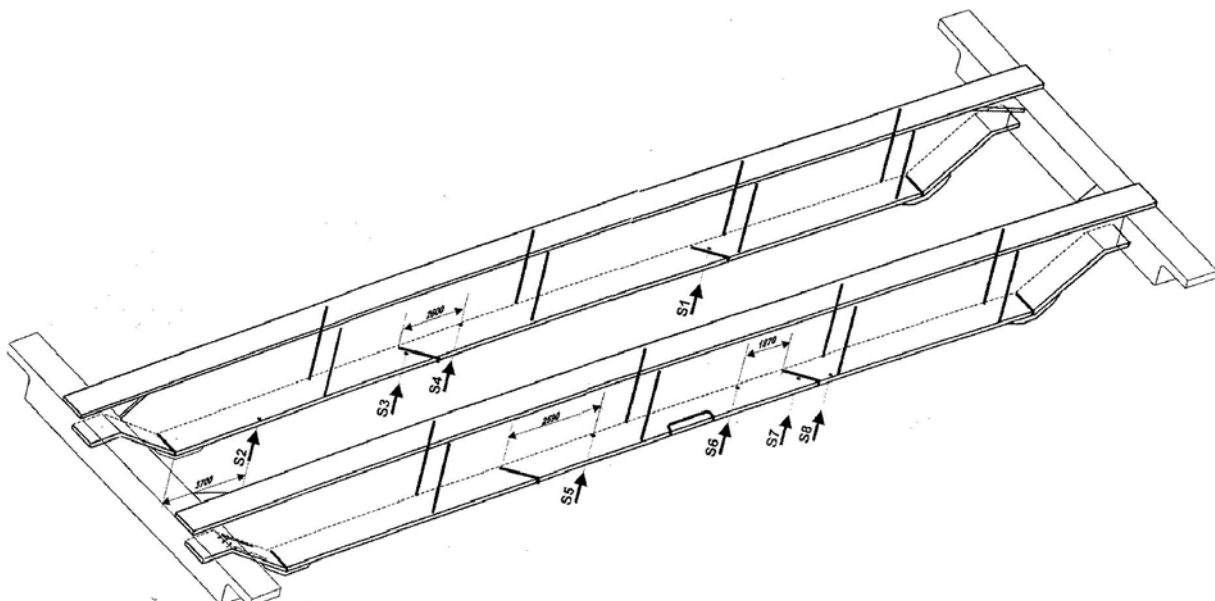
Fig. 2. Scheme of investigated crane bridge with flaw detector investigation zones
Rys. 2. Schemat badanego mostu suwnicowego z umiejscowieniem stref badan defektoskopowych

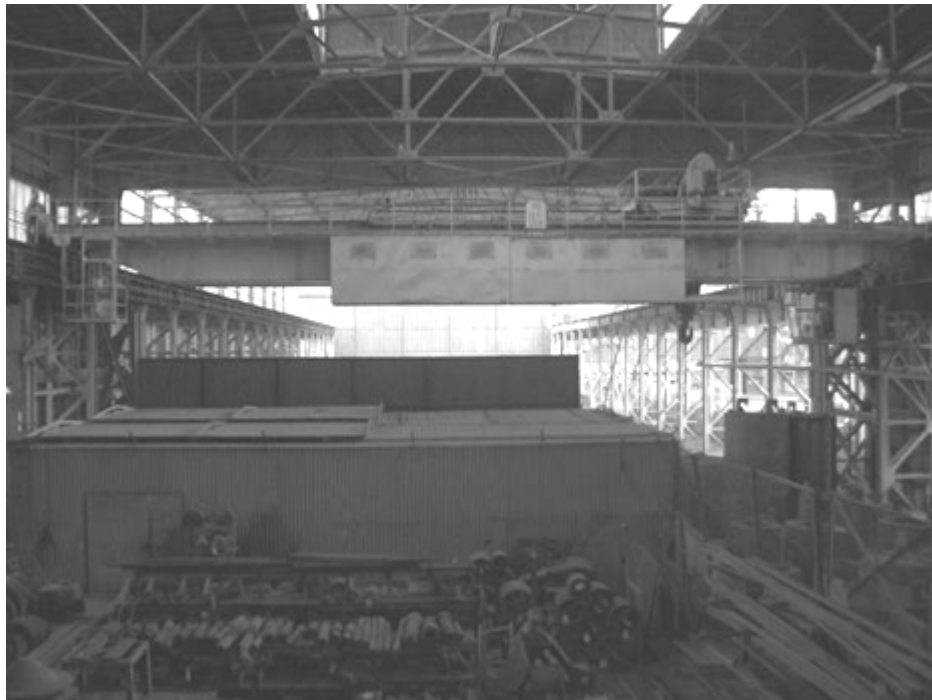
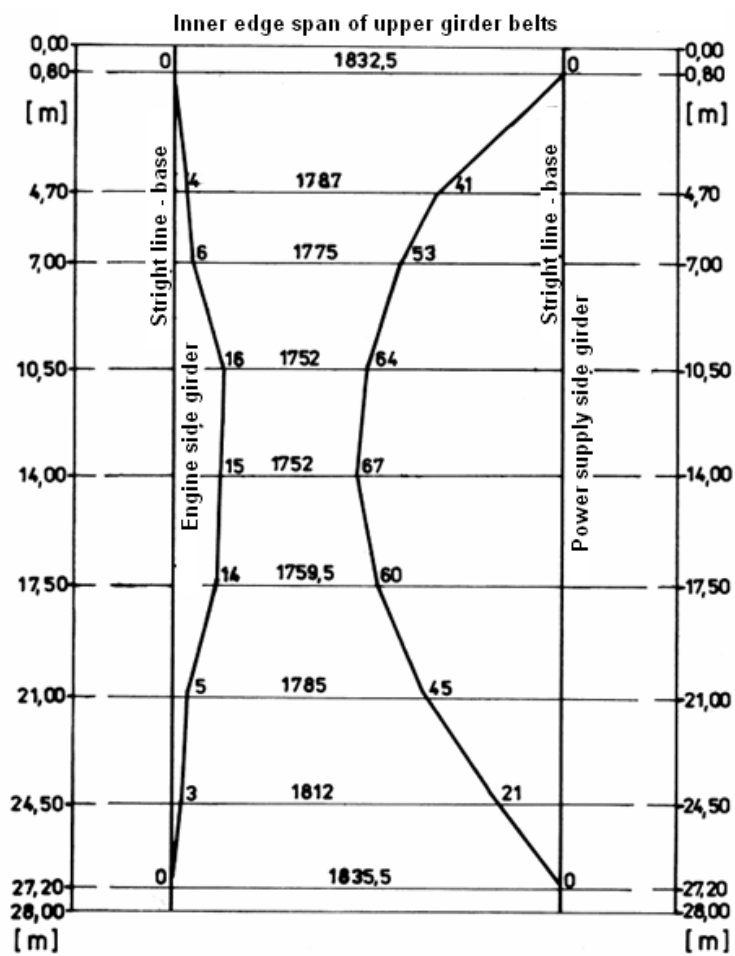
Fig. 4. Picture of crane and geodesic investigation results

Rys. 4. Zdjęcie suwnicy wraz z operatem geodezyjnym rezultatów trwałych ugięć dźwigarów mostowych

Next figure (fig. 4) presents results of permanent deflected bridge crane girders geodesic investigation and picture of crane.

Metallographic research of samples with nonmetallic inclusions plastically deformed and low cycle fatigue loaded have shown appearance of cracks parallel to deformation direction of nonmetallic inclusions (SiO_2 , MnS , Al_2O_3) and steel division border. In consequence it leads to plate stratifying (fig. 4).

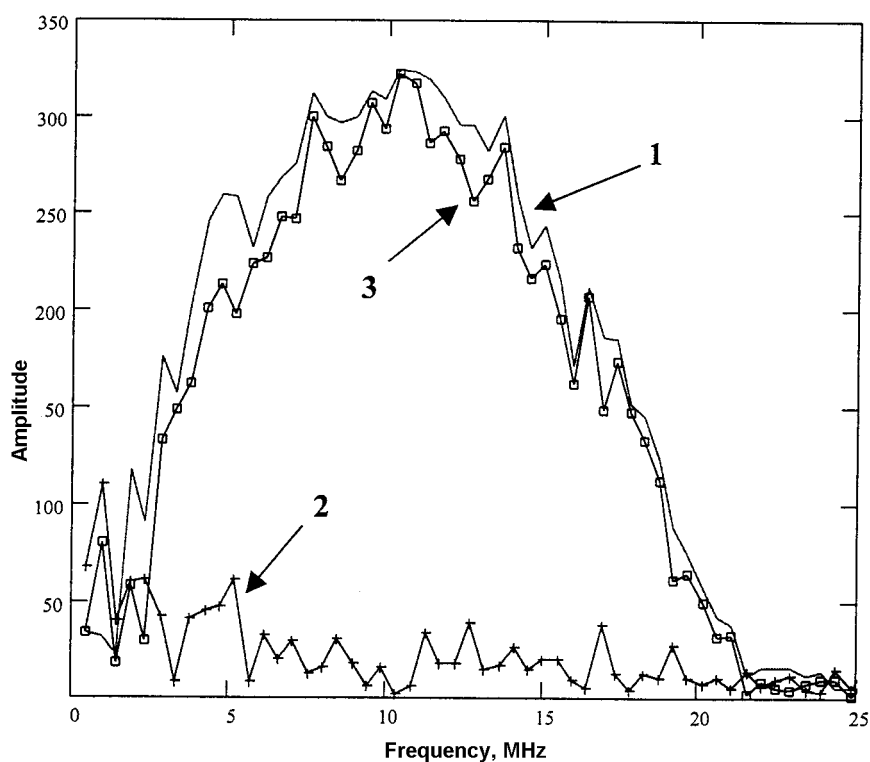
Fig. 6. AC characteristics for clean iron – curve 1 and steel – curve for amplification of 72,5 db

Fig. 5 presents characteristics for clean iron ($d=8$ mm polished surface - curve 1) and including small nonmetallic inclusions ($d=10$ mm coarse surface - curve 2). During analysis of AC characteristic noise of measurement equipment has been seen. Fig. 6 shows measurement characteristic (with 72,5 dB amplification) on clean iron (curve 1) and for steel (curve 2).

Maximum noise is for frequency 2-2,5 MHz (beyond measurement range 13-22 MHz).

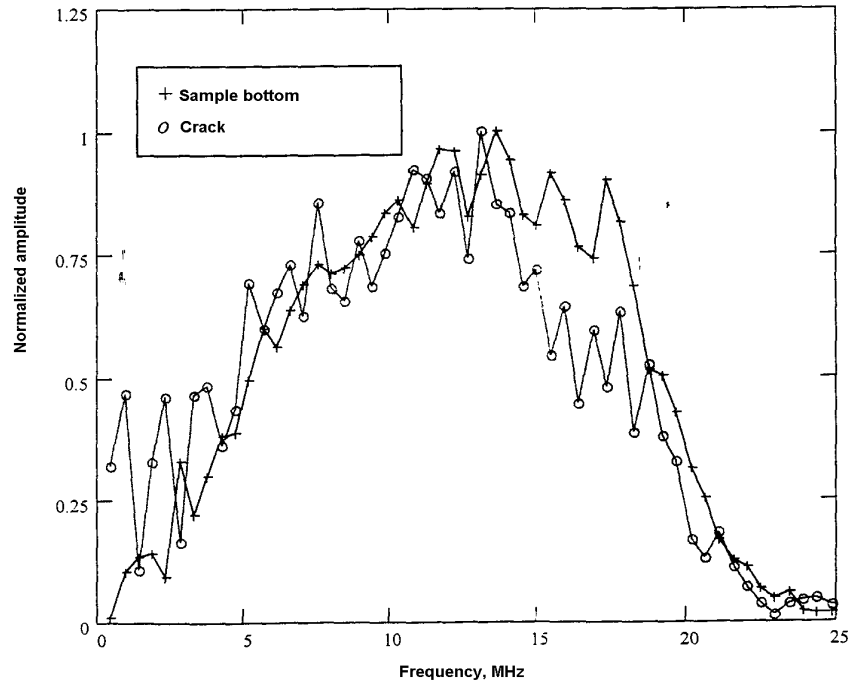
Fig. 7. Signal reflected from crack
Rys. 7. Sygnał odbity od pęknięcia

Application of FFT allows to distinguish signal reflected from cracks and reflected from laminated arranged nonmetallic inclusions.

Fig. 7 shows signal reflected from crack and fig. 8 from inclusion.

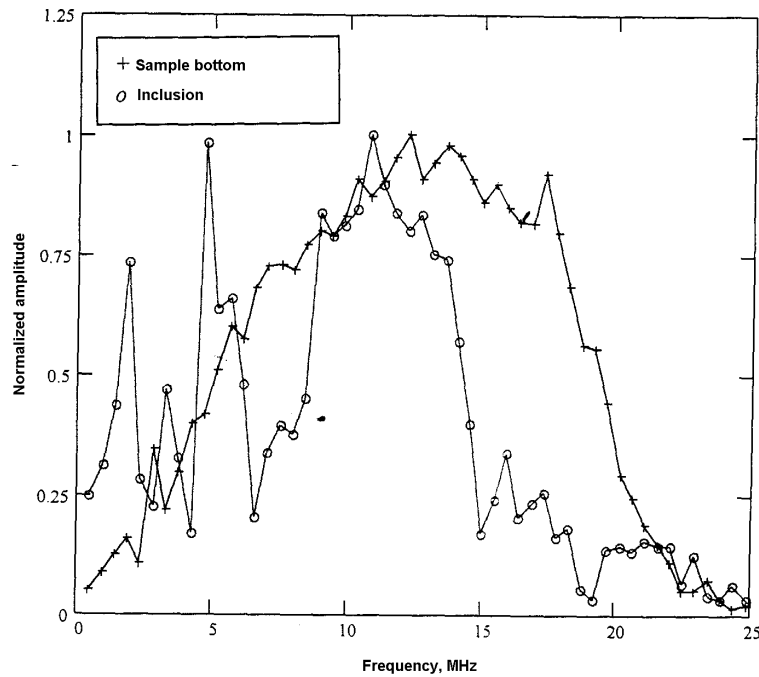
Fig. 8. Signal reflected from inclusion
Rys. 8. Sygnał odbity od wtrącenia
